# A Survey Report on Pavement Damage in the Disaster Areas of Tohoku

**MASAYUKI HASHIMOTO**, RESEARCH AND DEVELOPMENT CENTER TAIHEIYO CEMENT CORPORATION,2-4-2,Osaku,Sakurashi,Chiba Prefecture,285-8655,JAPAN

We surveyed the areas damaged earthquake and tsunami from early April, 2011.In this paper we report on the investigation about damage and temporary restoration situation to pavements by this earthquake.

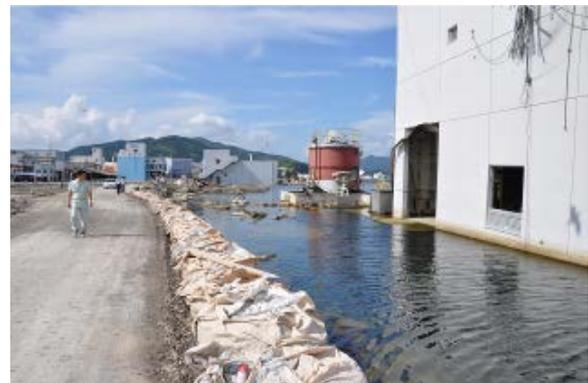
Photo 1 was taken at the Port of Kesennuma in Kesennuma City. The city was devastated by the tsunami, and the streets were flooded due to the subsidence.

Photo 1 The port facilities flooded due to the subsidence

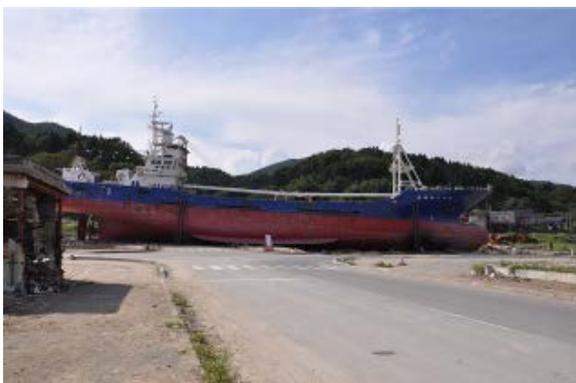
Photo 2 was shot at a site several hundred meters inland from the Port of Kesennuma. A large fishing boat carried by the tsunami was sitting on the road. This picture shows that the pavement remained unbroken, while houses and buildings were destroyed by the tsunami.

Photo 2 A large fishing boat carried inland by the tsunami

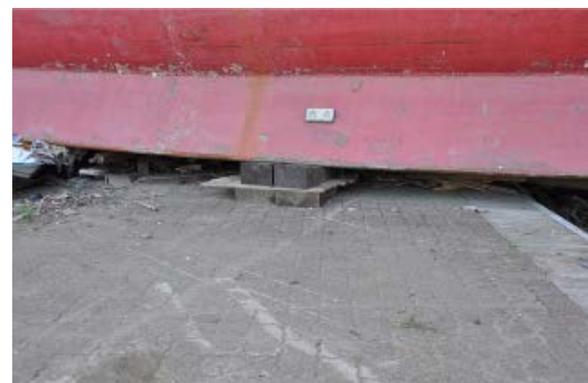
Photo 3 shows an interlocking block used as the base for the support which was applied to prevent the fishing boat from toppling over. The block was withstanding the load without fracturing.

Photo 3 Wooden support applied to prevent the fishing boat from toppling over

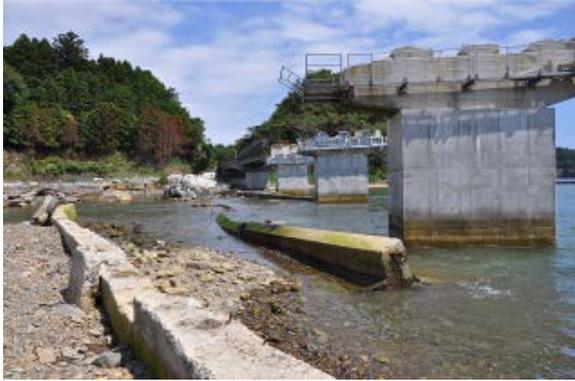
Photo 4 shows a road bridge on National Highway 45 located on a coastal site in Utatsu district, Minamisanriku Town. Only the piers remained standing, with the upper girders destroyed and carried by the tsunami. This picture depicts the extraordinary power of destruction the tsunami had.

Photo 4: A road bridge destroyed by the tsunami

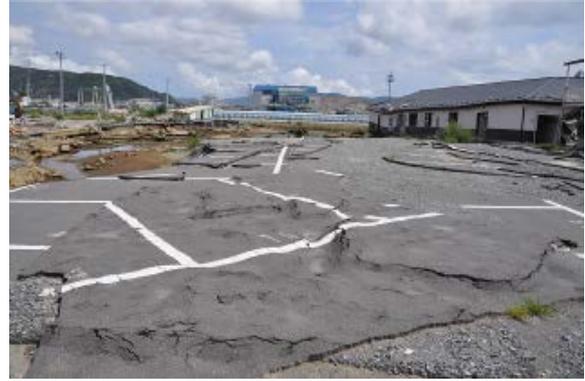
Photo 5 shows a car park next to the Ishinomaki Municipal Hospital located on a coastal site in Ishinomaki City. The vastly exposed land shown at the back left in the picture suggests that the tsunami eroded the ground around the pavement and carried the surface course with its backwash.

Photo 5: Pavement of a car park destroyed by the tsunami

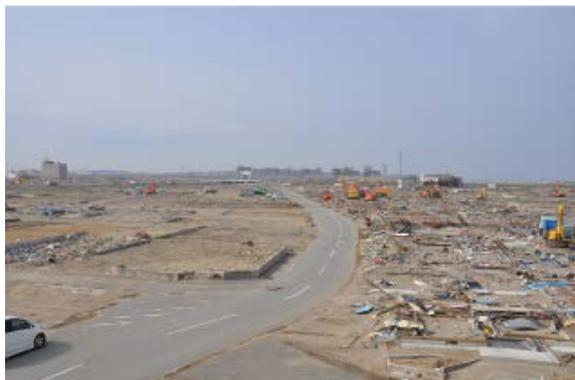
Photo 6 was taken in Yuriage district downstream the Natori River. Although the whole town was devastated by the tsunami, pavement remained undestroyed. This was likely due to the confinement provided by the remaining foundations of the houses and buildings surrounding the pavement.

Photo 6: A town devastated by the tsunami

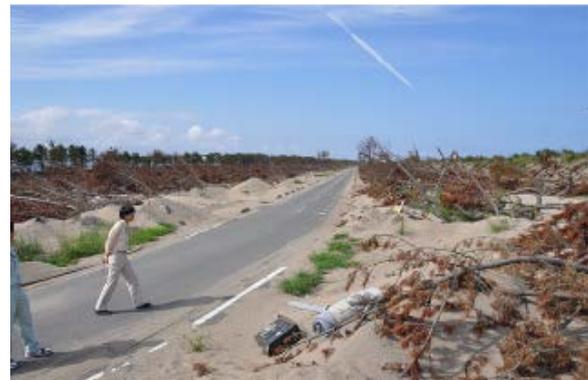
Photo 7 was taken at the Watari Bridge crossing the Abukuma River in the coastal area. The tsunami overrode the breakwater shown at the right in the picture and prostrated the tide- and wind-protective forest. It is likely that the remaining roots of the forest trees restrained the pavement and prevented the surface course from being carried away.

Photo 7: Damaged tide- and wind-protective forest

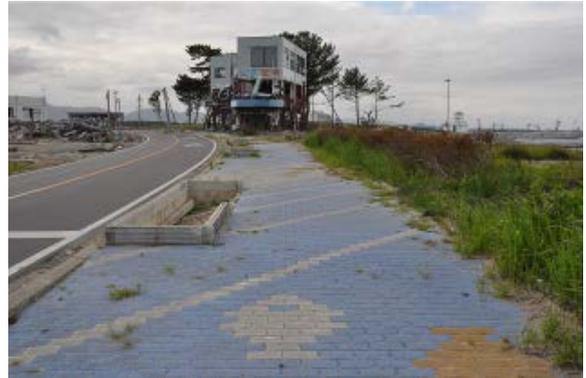
Photo 8 was shot near the Soma Fishing Port in Soma City. No major damage was found in the interlocking block-paved walkway or the asphalt-paved driveway, while the buildings shown at the right and back center in the picture were destroyed by the tsunami. The interlocking blocks remained unbroken, although the pavement partly crumbled where the periphery curbs were destroyed by the tsunami.

Photo 8: Interlocking block pavement swept by the tsunami

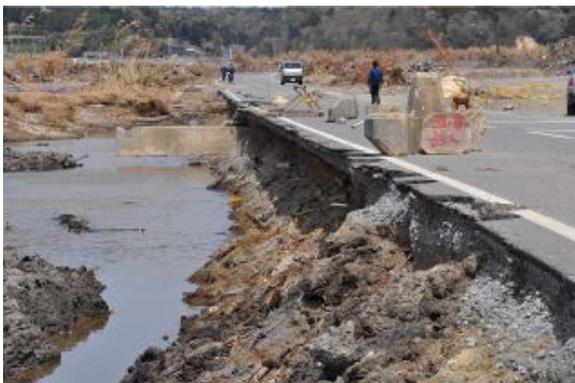
Photo 9 shows a prefectural road in Minamiebi district, Kashima-ku, Minamisoma City. The

road is located immediately at the back of a breakwater. Although the surface course narrowly remained in place, the road is in danger of collapse, with its shoulder extensively eroded by the tsunami which overrode the breakwater.

Photo 9: The road shoulder eroded by the tsunami

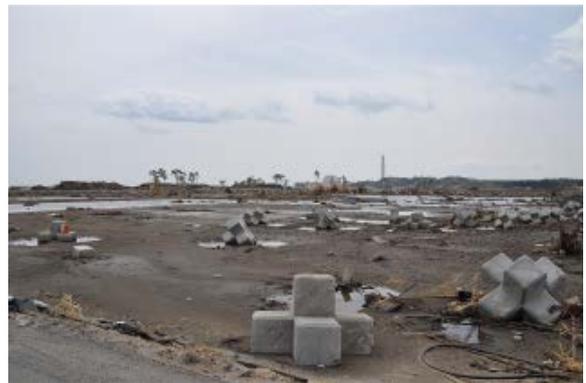
Photo 10 is a shot taken at Haramachi-ku, Minamisoma City. The pavement was found severely damaged, with its surface course removed at many spots. There were a lot of precast concrete armor units, as well as U-shaped gutter segments from the irrigation channels, lying scattered over the nearby farmland. It is likely that these concrete blocks and debris carried by the tsunami hit and destroyed the pavement surface.

Photo 10: Precast concrete armor units lying scattered over the farmland

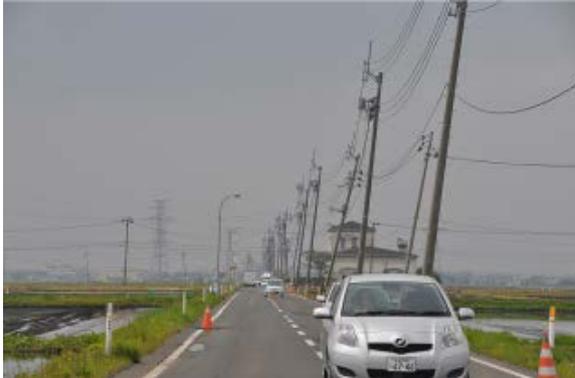
Photo 11 shows the consequences of liquefaction found in a rice paddy field area in Inarido district, Wakabayashi-ku, Sendai City. The utility poles were leaning due to the liquefaction.

call their attention to bumps and cave-ins made in the roads by the liquefaction.

Photo 11: Leaning poles due to liquefaction

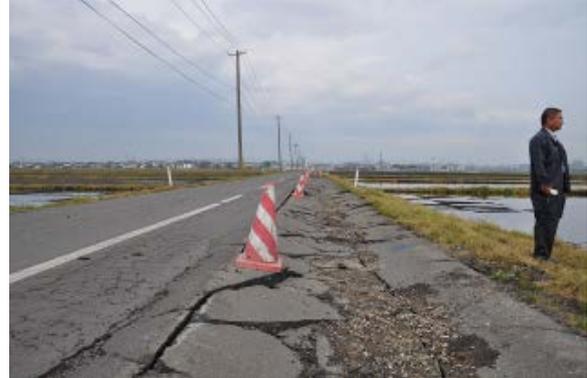
In Photo 12 the right-hand strip of the road collapsed longitudinally for a considerable distance. There was a water main buried beneath and along the road surface. It is likely that the higher groundwater level than those in the surrounding soil caused liquefaction of backfill sand.

Photo 12: Road surface collapsing due to liquefaction

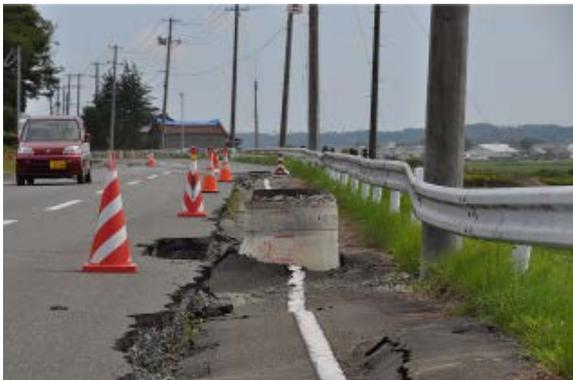
Photo 13 shows a cave-in made in the road surface. A deep and wide cavity was found beneath that by visual check at the site. The heat during the summer increased the road surface temperature and thus decreased the asphalt viscosity, presumably allowing for a collapse of the asphalt mixture due to its weight. This specific spot was likely to have been prone to the collapse by self-weight because of the cavity generated beneath the surface and base courses (the pavement structure) due to the liquefaction.

Photo 13: A cavity beneath the road surface found after the collapse of the hot mix asphalt (HMA)

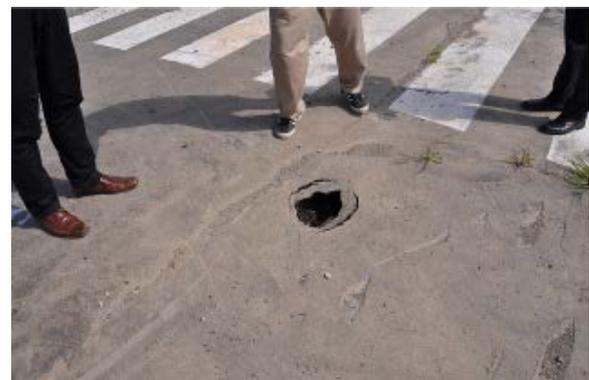
Photo 14 shows one of the typical phenomena of liquefaction observed inland on a municipal road in Kashima-ku, Minamisoma City. The lifting of a drainage manhole in a farming village suggests liquefaction of the backfill sand.

Photo 14: A manhole lifting up due to liquefaction

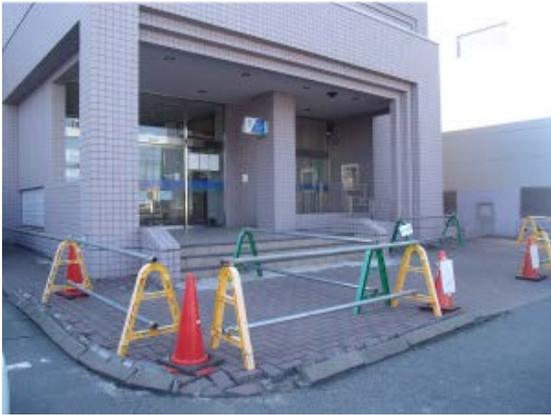
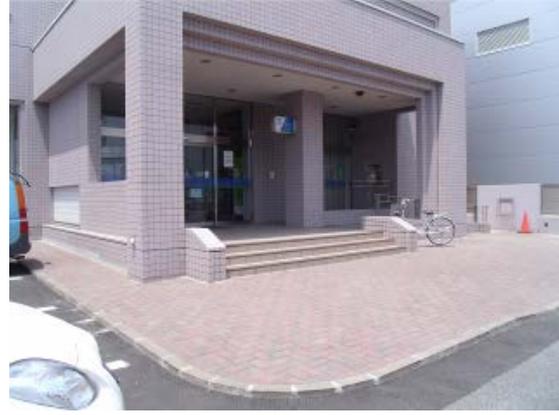
Photo 15 shows a walkway broken at its periphery. The right-hand (left-hand?) picture shows the walkway immediately after the earthquake, and the left-hand (right-hand) picture shows its temporary restoration. This site is located in Sendai City, Miyagi. Some of the interlocking blocks were found displaced due to loss of confinement where the walkway-driveway boundary blocks had a downward slope toward the driveway. The walkway was restored by reusing the existing interlocking blocks and restraining them at the periphery with new boundary blocks.

Photo 15 A walkway broken at the periphery

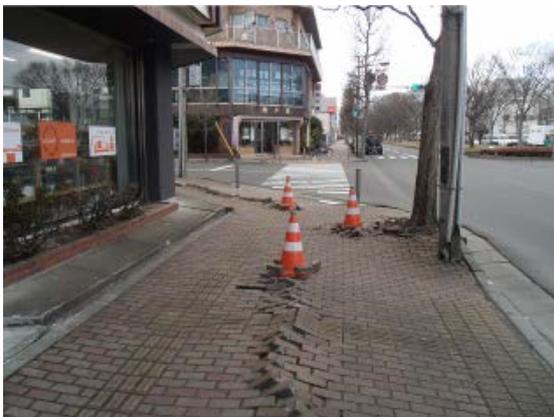
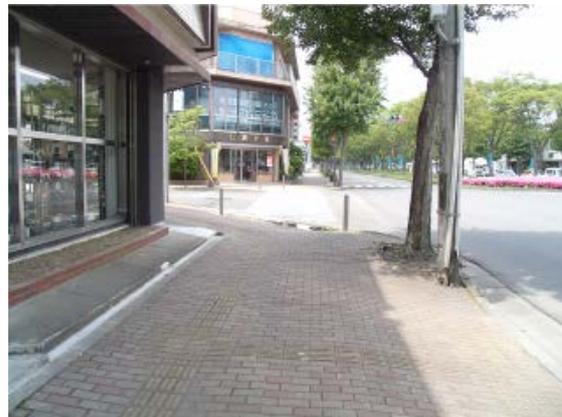
Photo 16 shows lift-up of interlocking blocks. The ground beneath the walkway subsided, while the periphery confinement at the right and left ends remained effective, consequently raising the pavement at the center. Since the pavement damage was minor with the blocks remaining unbroken, the blocks were not disposed of but reused in temporary restoration. The repair was made in the following manner:

Photo 16: Lift-up of interlocking blocks

- (1) The existing interlocking blocks and spread sand were removed from the raised areas, the base course was compacted using a roller, and the surface was leveled.
- (2) Joint sand was removed from the sides of the blocks for reuse, using wire brushes or similar.
- (3) Sand was spread, and the blocks were laid.

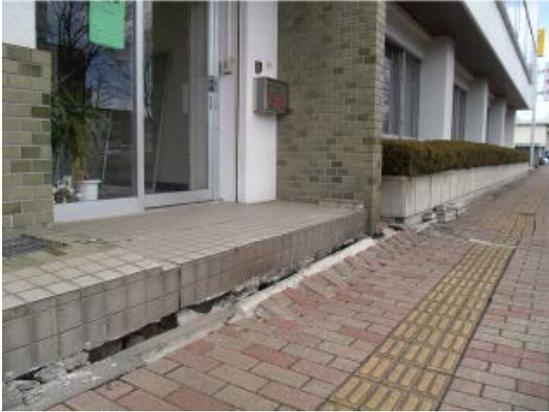
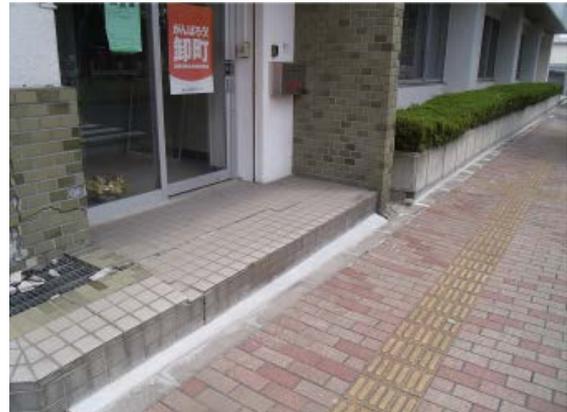
Photo 17 shows a gap generated between a building and an interlocking block pavement. The walkway pavement surface sunk entirely for about 10 to 20 cm, leaving open gaps and slopes around the building. Mortar was rubbed to cover the gaps and adjust the height at the entrance

Photo 17: A gap generated between a building and an interlocking block pavement

of the building. The existing interlocking blocks were reused in temporary restoration after confirming the absence of cracking and chipping.

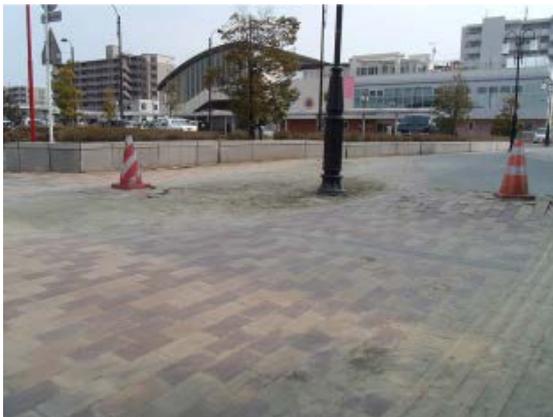
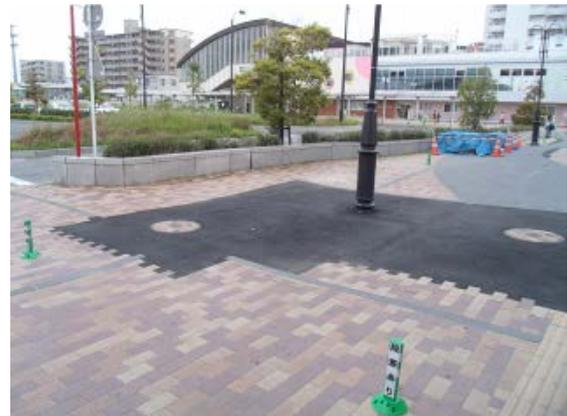
Photo 18 shows liquefaction of soil around a manhole and a lamppost. Liquefaction of soil around the manhole and the lamppost caused sand boiling and ground subsidence in the open space, leaving accumulation of soil on the surface. The sinking area was repaired with asphalt mixture.

Photo 18: Liquefaction of soil around a manhole and a lamppost

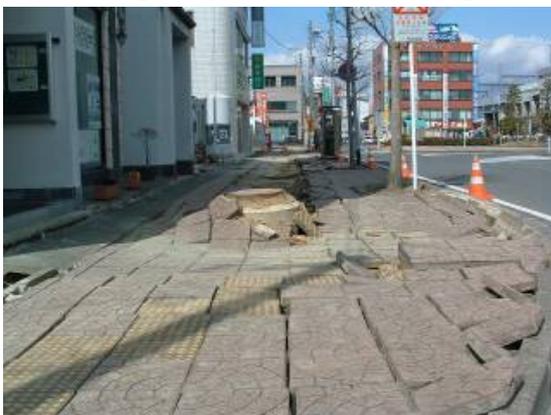
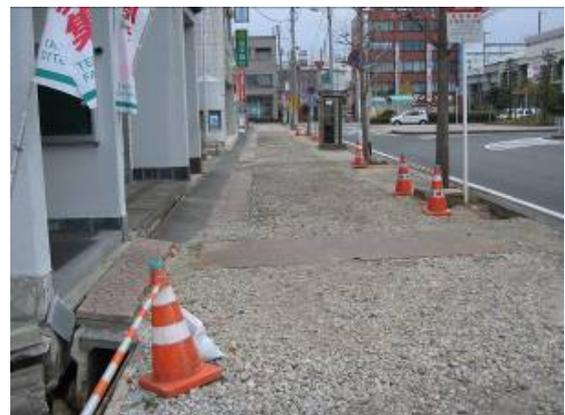
Photo 19 shows a manhole raised by liquefaction. Sand boiling was also observed, in addition to the lift-up of the manhole. Although the flat block pavement crumbled due to the rise of the

Photo 19: A manhole lifting up due to liquefaction

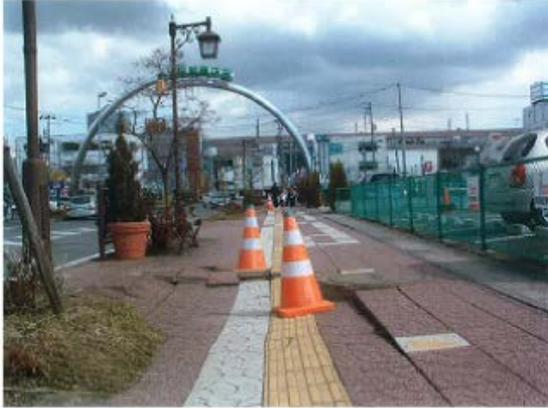
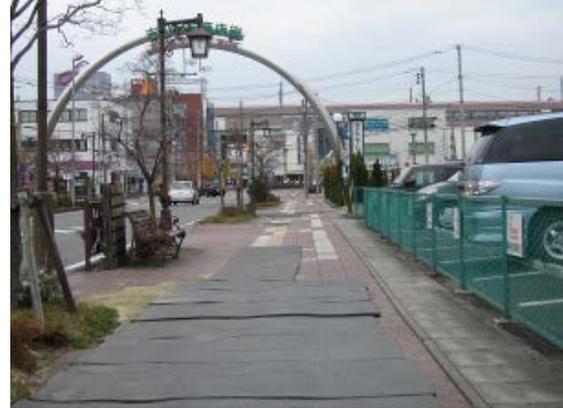
Photo 20: Flat block pavement damaged by liquefaction

ground or other causes, most of the flat blocks remained unbroken. The blocks were removed, and the base course was backfilled with crushed stone for temporary restoration. Photo 20 shows another flat block pavement damaged by liquefaction. The pavement partly lifted up due to liquefaction. The pavement surface was covered with rubber sheets for temporary restoration to ensure safety of pedestrians.

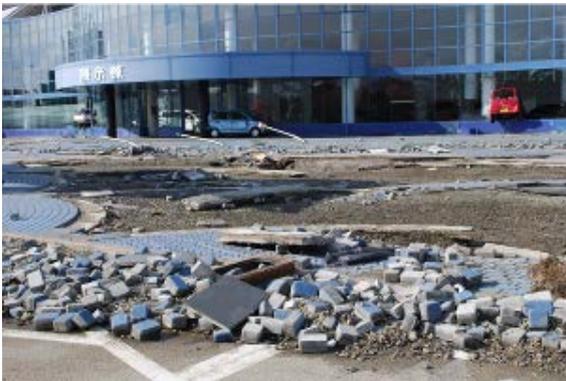
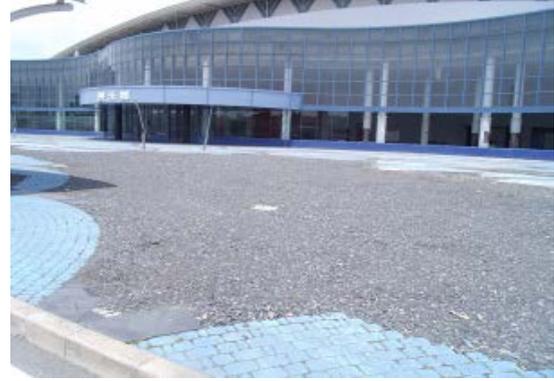
Photos 21 to 23 show interlocking block pavements damaged by the tsunami. Glasses on the building shown in Photo 21 were broken by the tsunami. Although the pavement crumbled into units due to displacement of periphery curbs, the interlocking blocks remained unbroken.

Photo 21: Interlocking block pavement damaged by the tsunami, 1

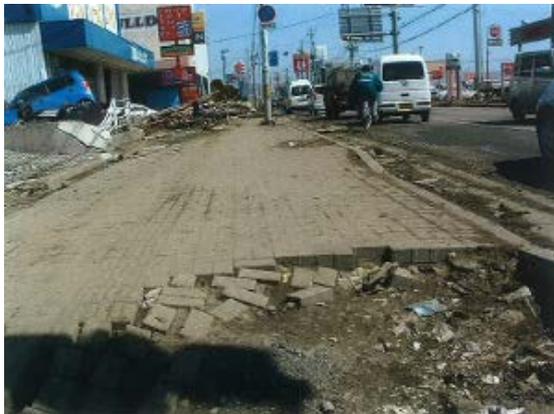
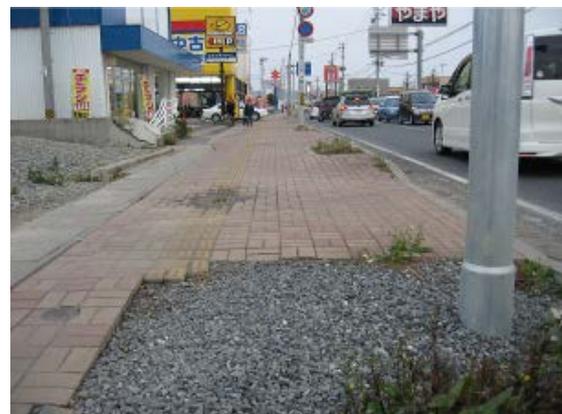
Photo 22: Interlocking block pavement damaged by the tsunami, 2

The ground around the interlocking block pavement was eroded by the tsunami where a utility pole was standing (Photo 22). Loosened blocks were carried away. This site was repaired by spreading new gravel over the base course for temporary restoration.

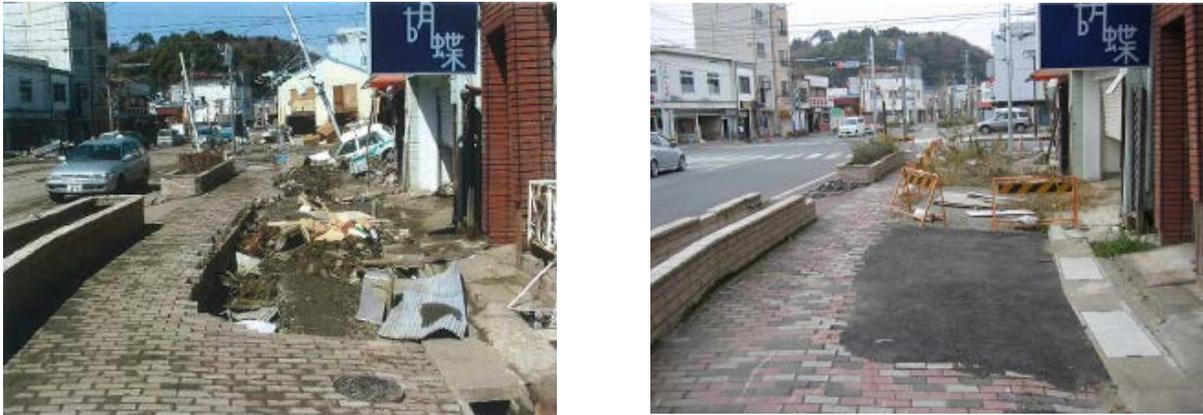
Photo 23: Interlocking block pavement damaged by the tsunami, 3

Damage shown in Photo 23 was likely to have been caused by the ground subsidence due to the earthquake which affected the interlock between the blocks in the pavement and allowed the loosened blocks to be carried by the tsunami. The walkway was repaired for temporary restoration, using asphalt mix in place of the interlocking blocks.
